# Assessment of Building Collapse in Nigeria: A Case of Naval Building, Abuja, Nigeria

## 5. THE COLLAPSED NAVAL BUILDING IN ABUJA

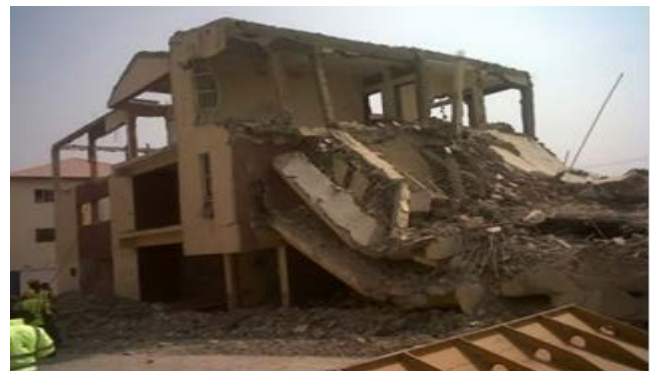
Plate 1: The Collapsed Naval Building located at Gwarimpa, Abuja, showing the wreckage. Source: Saharareporters, 2012)

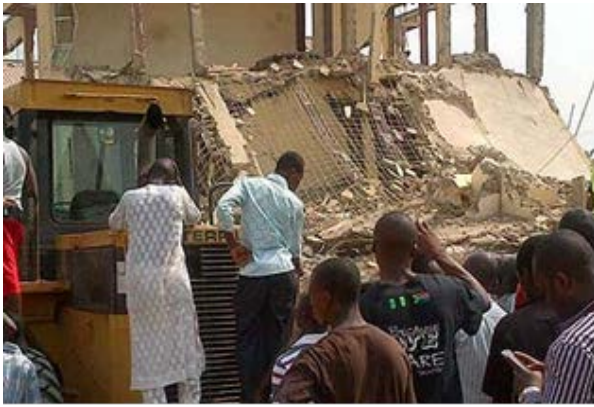
Plate 2: Clearing the debris on the Naval Building site  
(Source: Nnabugwu, 2012)

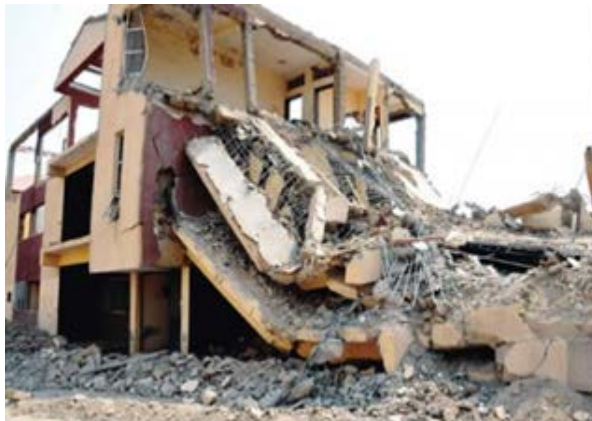
Plate 3: Another view of the building showing the wreckage  
(Source: Adepegba, 2012)

A critical look at the debris reveals the structural weakness of the construction materials used. Sub-standard materials were used in the construction of the building, which includes the reinforcement bars, concrete mixture ratio, etc. The mixture of the concrete was not distributed evenly. Therefore, it could be obtained that the workmanship during the construction of the collapsed building was poor. This as a matter of fact must also have contributed to the weak structural members such as columns, beams and slabs which led to the unsafe nature of the building.

- All building construction materials like sand, cement, aggregates, reinforcement bars and particularly foundation soil should be tested before commencement of any construction. The mineralogy and alkalinity tests of coarse aggregates should be done to know whether the material contains some percentage of impurities, which deleterious and injurious to cement and reinforcement rods.
