## **Weldability of Recycled Steel Bars in Uganda**

**Senfuka C., Kirabira J.B., Byauhanga J.K.**

Kyambogo University, Kampala District, Uganda

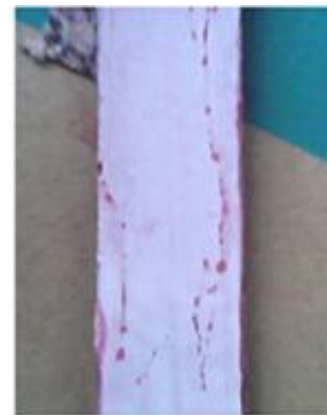
Fig. 5: Cold cracking, PV 19

On the other hand, Figure 5 shows the crack detection image of P19. This crack was identified in the base metal three days after weld solidification. This is the usual position for cold cracks. Although cold cracking could have taken place either in the weld metal or the HAZ depending on which is more susceptible, the peak hardness and strength values in the HAZ are greater than those of the weld metal in sample PV19 according to micro-hardness plot in Fig.6. So, a typical hydrogen crack had to occur in the HAZ. The presence of crack promoting elements like Boron, chromium etc (equation

In the case of PV19, the face hardness plot indicates the expected reduction in hardness in the weld fusion zone but suddenly drops 30 HRb units towards the right edge of the sample. The crack is located outside the weld and is well inside the parent metal.

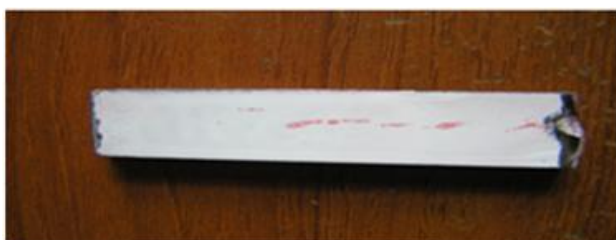
Out of the thirty samples welded and tested, four showed evidence of weld induced cracking. Fig. 5 shows sample PV5 with a typical centerline crack while Fig. 4 shows a HAZ crack after micro-finishing and treatment with die penetrant and developer.

Fig.4: Centerline crack, PV5

The gradual drop in micro surface hardness of sample PV5 is the expected result of the lower tensile strength of the filler metal, being 330Mpa, reducing gradually due to penetration and dilution between stronger ( $\sigma_u=498\text{Mpa}$ ), higher carbon equivalent base metal and the filler rod (Table 2 and 3). The additional drop just before the crack indicates that the centerline crack is related to the reduced hardness of the material around the crack. This actually shows that the crack is the result of solidification cracking derived from the accumulation of low melting temperature, softer material during the solidification process towards the center of the fusion zone, providing

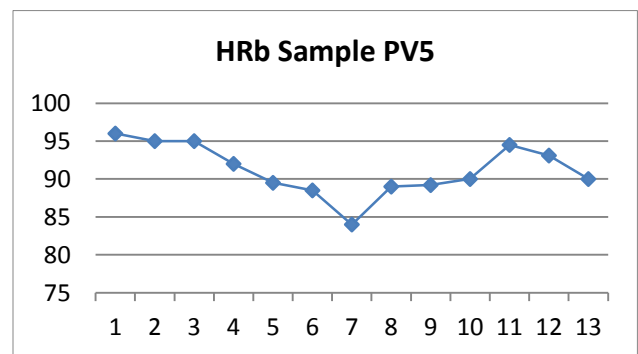
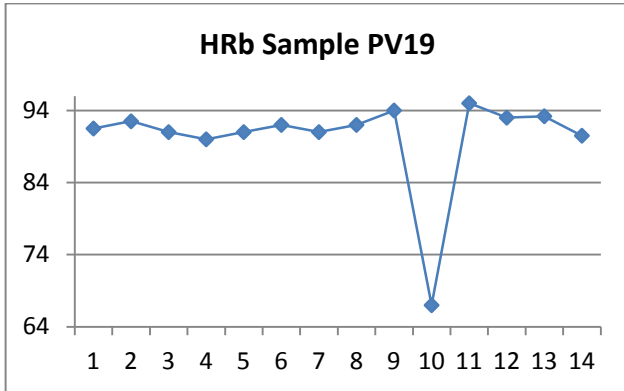
Fig.6: Micro-hardness plot for PV5 and PV19

The micro-hardness graphing across the face of the samples PV5 and PV19 is shown in Fig. 6. The hardness value at the centre of PV5 gradually drops ten HRb units below that of the base metal in response to the lower carbon equivalent of the filler rod (See Table 3) in the center in comparison to the edges. The final five units drop in hardness is in the center of the sample, showing the position of the crack.

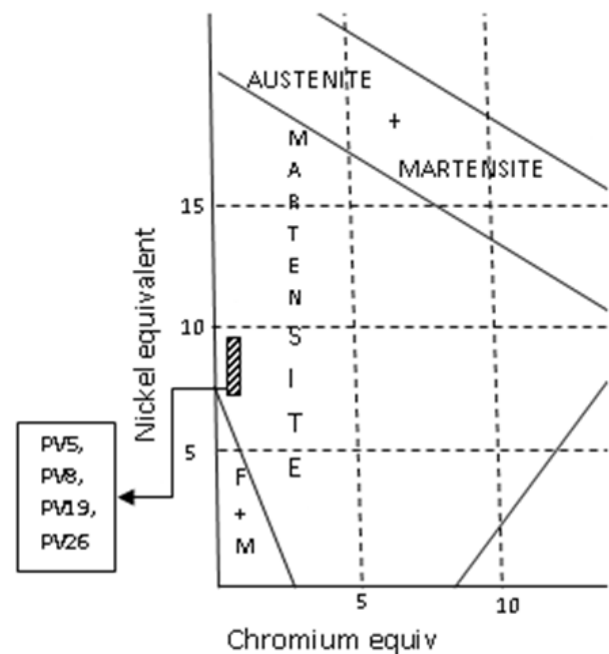
Fig 7. Schaeffler diagram for PV5, PV8, PV19, PV26

The corresponding position on the Schaeffler diagram drawn from Table 2 for the four steels is as shown in Fig.7.

It can be seen from this diagram that the tendency to formation of martensite and other non-equilibrium products is substantial. This provides ideal conditions for cold (hydrogen) cracking which then only depends on the weld design.

All steels in this study have carbon equivalent above this limit although they are not particularly high in carbon content (Table 2). This means that the overall tramp element content is the major factor behind this elevated carbon equivalent value.
