## On Investigating Pollution of Groundwater from Atenda Abattoir Wastes, Ogbomoso, Nigeria

Adegbola, Adedayo Ayodele<sup>1</sup>, Adewoye, Abosede Olufunmilayo<sup>2</sup>

<sup>1</sup>Department of Civil Engineering, Ladoke Akintola University of Technology, Ogbomoso, Nigeria

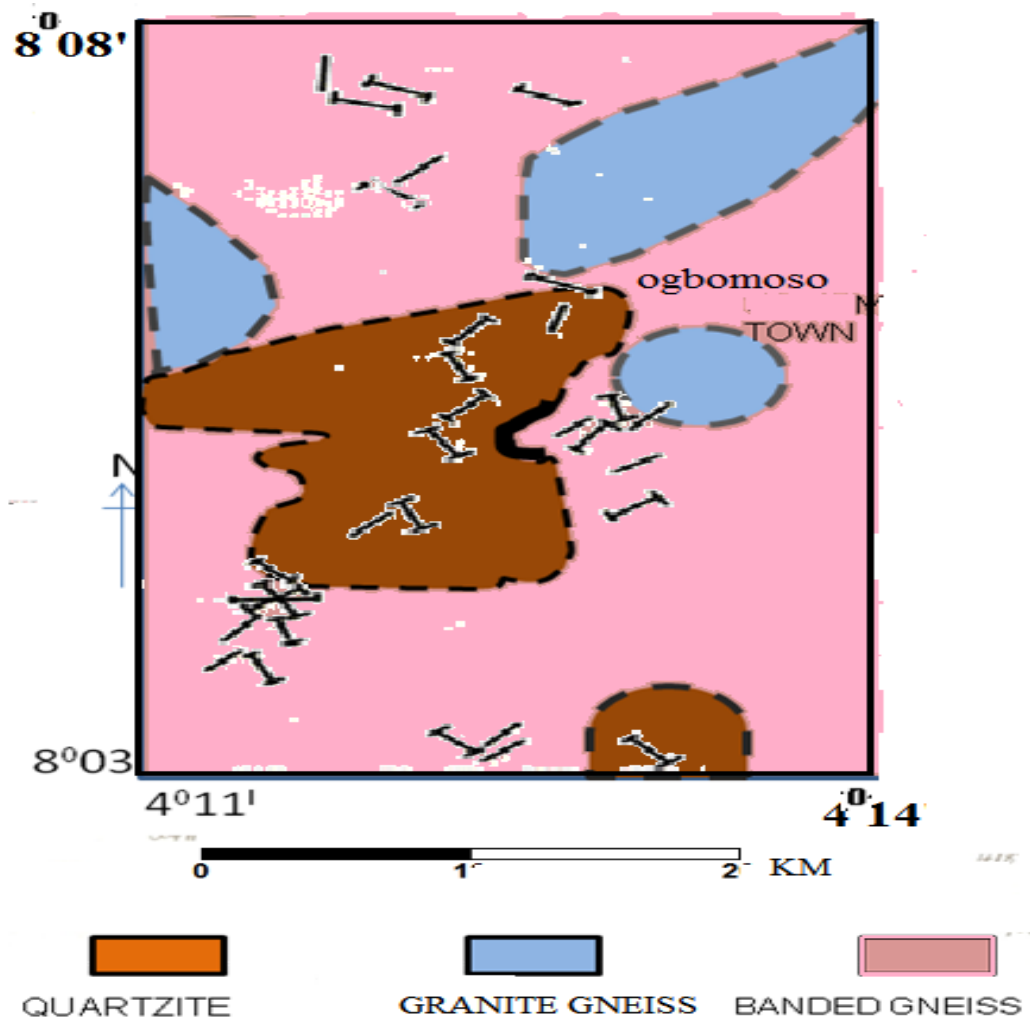
Figure 5: Geological Map of the Study Area

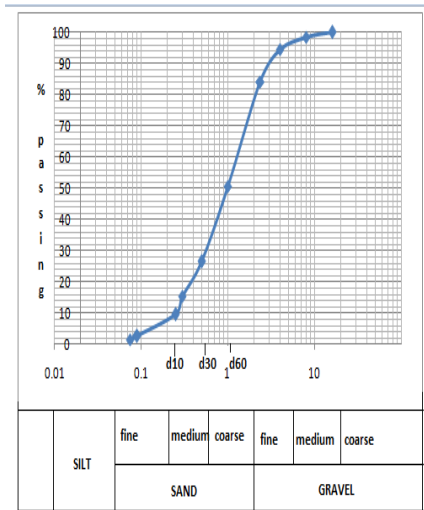
Figure 8: Graph Of Particle Size And Percentage Finer Than d For Sample 3

Sample 3 is a poorly graded soil, because it has its Cu to be 4.7 and Cc to be 1.0 and these values meet the requirement for a poorly graded soil. It can be seen from the above values that the total value of sand is higher than that of the gravel, hence sample 3 is a poorly graded gravelly-sandy soil. A well graded soil is a soil that has a good distribution of sizes in a wide range, where smaller grains fill the voids created by the larger grains thus producing a dense packing. The grain size distribution

curves for such soils would generally be smooth and concave. In poorly graded soil (uniform), the grains are about the same size. Based on grain size distribution, soil A and B, which are well-graded, contain enough smaller particles to pack around the big ones and fill the voids, resulting in low water flow, while soil C, that is poorly graded, will result in high water flow. Soil C, therefore, will allow for high accumulation of contaminants into the subsurface strata, and in extension, the groundwater.

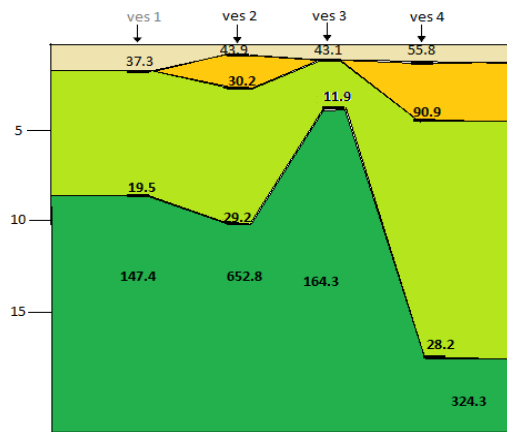
Figure 9: Goelectric Section for VES 1-4

The results of the interpreted VES curves (Figures 9, 10 and 11) were used to draw 2D geoelectric sections along profiles 1-4 (Transverse one), 5-7 (Transverse two), 8-11 (Transverse Three), to show the vertical distribution of resistivities within the volume of the earth in the investigated area. The sections consist of sequence of uniform horizontal (or slightly inclined) layers (horizons). Each layer (horizon) in a geo-electrical section may completely be characterized by its thickness and true resistivity. The geoelectric sections show both vertical and lateral variations in layer resistivity.

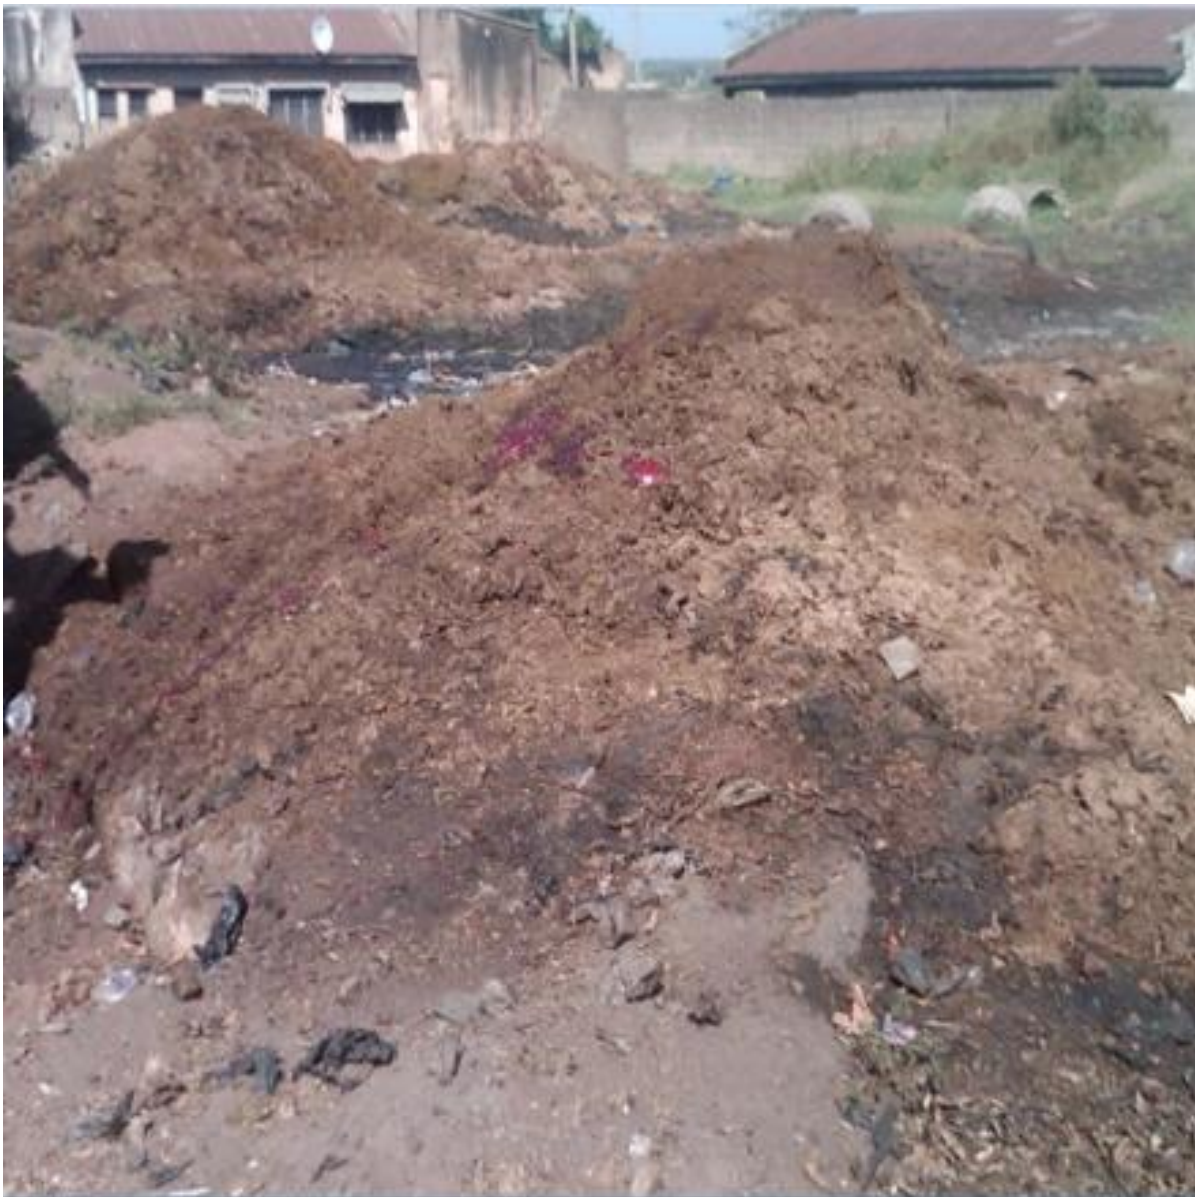
Plate 1: Waste Dump Of Atenda Abattoir, Ogbomosho

The vegetation of this area is that of the rainforest and derived savannah. The composition is basically the tall crowned trees mixed with thick undergrowth. The trees attain the height of about 20-40m, and grasses are abundant and luxuriant. The typical type of the grass here is that of elephant grass and stubborn grass. The tropical trees are locust beans and most of the trees are deciduous. The climate condition is typical of the south western part of Nigeria whose climate is influenced largely by equatorial maritime air mass. The study area is relatively rugged with undulating topography (Figure 1). The Sunsun and its surrounding environment is exactly 325m and the general elevation varies between 309m and 325m above mean sea level. The average elevation above sea level is about 314m. Figure 2 depicts the graphical details of the study area. The drainage, location and geological maps of the study area are presented in Figures 3, 4 and 5, respectively. Plates 1 and 2 represent the waste dump site of Atenda Abattoir and one of the sampled wells, respectively.

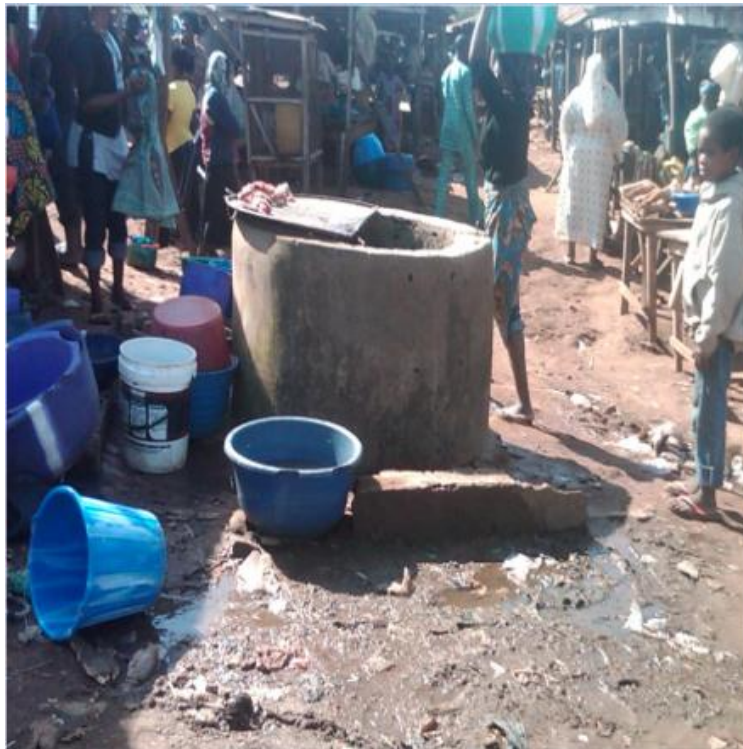
Plate 2: One Of The Sampled Well At Atenda Abattoir
