## Contribution of Locally Designed and Fabricated Vehicle Seats to Accident Injuries in Ghana.

This paper sought to find evidence support of this hypothesis. The results of a kinematic analysis performed with the Working Model 2D software were compared with the results from a Mini Survey that was conducted between November 2011 and January 2012, at the Accident and Emergency Centre of the Komfo Anokye Teaching Hospital, Kumasi, Ghana.

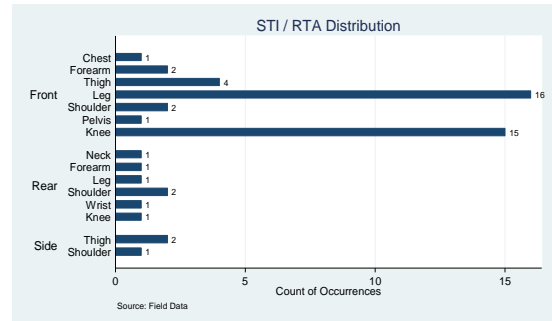
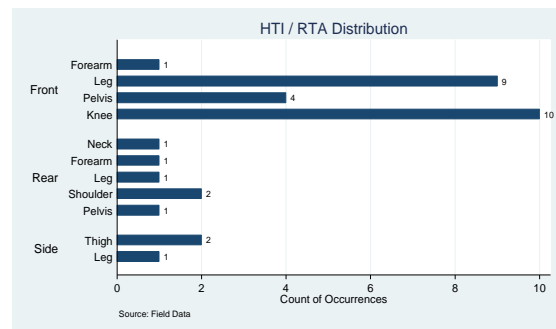
Fig. 5: Analysed Injury Data [(a) Analysed Data on STIs (b) Analysed Data on HTIs]

Injury data was collected from thirty-one accident victims between November 2011 and January 2012. Eighty-four injury occurrences were recorded. The injuries were grouped into Soft Tissue Injuries (STIs), which refer to flesh and muscle injuries, and Hard Tissue Injuries (HTIs) which refer to fractures and dislocations. An analysis of the recorded injury occurrences are shown in Fig. 5 and Fig. 6.

It was realized that, as was observed from the simulation, most of the injuries recorded (both STIs and HTIs) were sustained in the knees and legs of victims (See Fig. 5). A few pelvic injuries were also recorded, confirming that impact forces are transferred to victims' hips during these accidents.

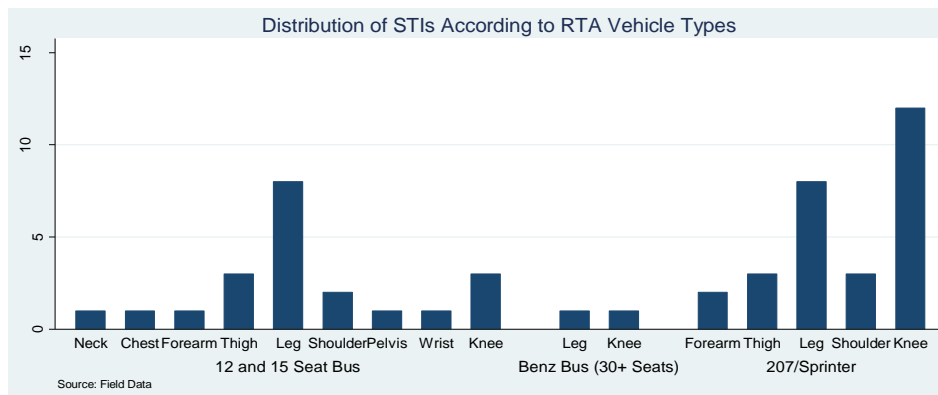
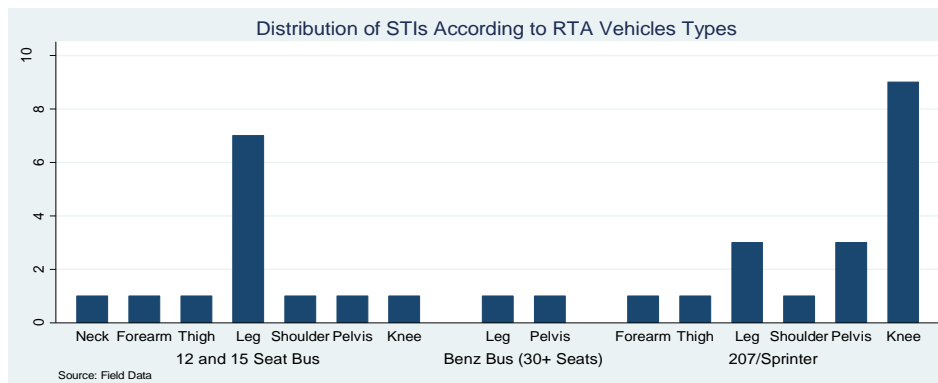
Fig. 6: Locations of Injuries Sustained in Various Vehicle Types. [(a) STIs (b) HTIs]

A further analysis of the injury locations, from the vehicles in which they were sustained indicated that, most of the knee injuries (both STIs and HTIs) were sustained by victims from the 207 and Sprinter type of minivans as indicated in Fig. 6. This, it is believed is due to the fact that, the bases of the seats found in these types of buses are generally higher of the ground than those found in the 12 and 15 Seat Buses (See Table 1).
