# Corrugated Laterite Based Ceramic Roof Tile Stabilized with Cement

## ABSTRACT

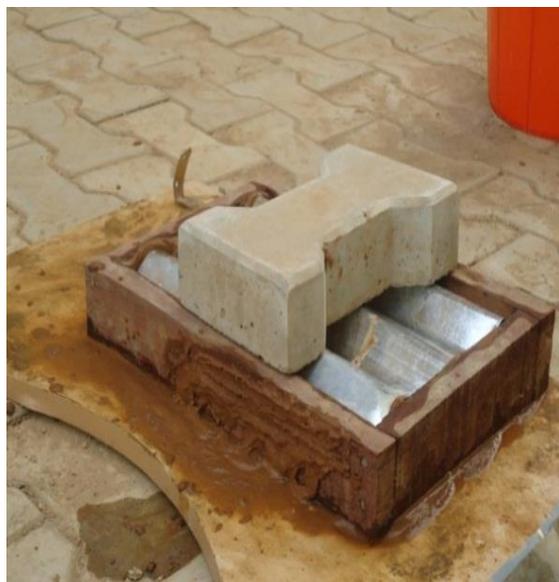
Two samples A and B of laterite based corrugated ceramic roof tile were prepared, varying the cement and laterite compositions. The size of the samples was 200 mm x 300 mm x 20 mm. Paste of laterite-cement mix was formed with water to cement ratio of 3:1. The paste was poured into a wooden frame with underlying corrugated metal sheet. Another corrugated metal sheet was placed on the paste to form the corrugated shape. The samples were air dried for 14 days.

Figure 1: Freshly prepared sample

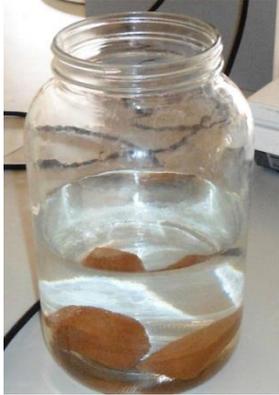
Water absorption test was carried out on samples A and B matrices. Dry mass ( $W_d$ ) of the samples were weighed. The samples were then soaked in water until no bubble was observed. Excess water was removed from the samples using tissue paper and the wet mass ( $W_w$ ) was also weighed.

Figure 3: Samples soaked in water

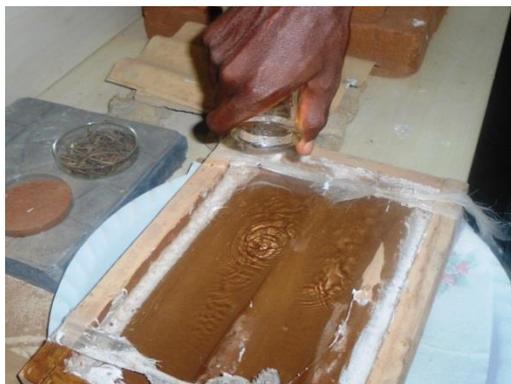
The cast samples A and B of the corrugated ceramic roof tile were placed in the wooden frames used in their casting. The clearance between the casts and the frame was filled with RTV Silicone Sealant to prevent water leakage. Measured amount of water was poured into the set-up and the time taken for the first drop of water from below the set-ups was recorded.

Figure 4: Sample tested for water penetration

Table 2, shows the water penetration results for sample A and B, which indicates an increase in the penetration time as the percentage of cement increases, this is because of the increase in binding properties between the laterite and cement content when increased from 15% to 20%, which reduces the amount of pores present, hence an increase in the water penetration time. This shows a relationship between the SEM and the water penetration results, since the cement fill up the interstitial position in the laterite, which reduces the amount of pores, makes it difficult for water to penetrate; hence it takes a longer time for water to penetrate through.

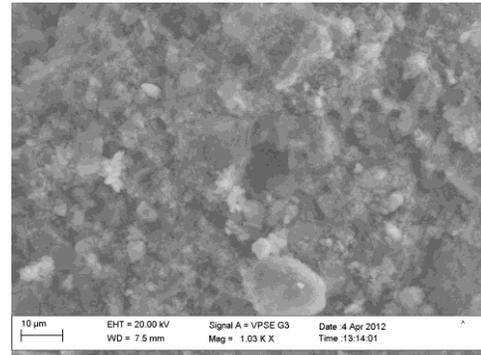
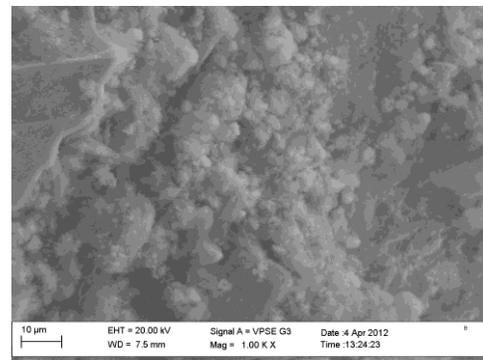
Figure 5: SEM for sample A

Figure 6: SEM for sample B

The results obtained from the Scanning Electron Microscopy (SEM), Energy Dispersive X-ray Spectroscopy (EDS), Water absorption test and Water penetration test indicates the microstructure, element present and properties of the corrugated ceramic roof tile. Figure 5 and 6, shows the SEM results from sample A and B, which indicates the level of pores present in the both samples, it shows a decreasing level of pores as the percentage of cement is increased from 15% to 20%, which indicates that the cement serves as a binding agent for the corrugated laterite ceramic roof tile. Sample A has very little pores, while sample B has fewer pores and is more compacted than sample A, this is as a result of the cement being a good binder, it tends to occupy interstitial positions in the laterite structure, thereby reducing the atomic separation distance and having a more closed packed structure. Finer grains tends to bind together better than larger grains, and since the laterite has fine grain and the cement is much finer, it makes them bind together properly, which reduces the level of pores present.

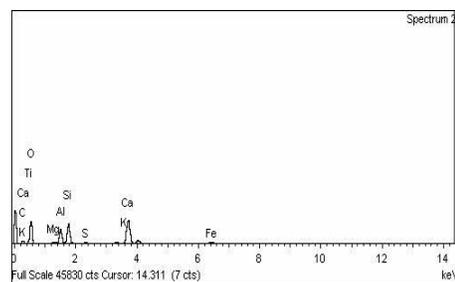
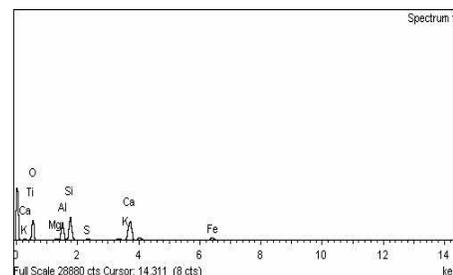
Figure 7: EDS result for sample A

Figure 8: EDS result for sample B

Figure 7 and 8, shows the EDS result for sample A and B, this indicates elements present in the corrugated ceramic roof tile and since the both samples A and B where both from the same source they both have similar EDS result, which confirms that they are from the same source. The EDS result indicates the present of K, C, Ca, Ti, O, Mg, Al, Si, S and Fe, these elements are usually obtained from laterite ceramic, the light reddish colour is as a result of the low level of Fe present as shown by the EDS result and sample B tends to have more Ca than sample A, this indicates an increase in cement for sample B. Table 1, shows the water
